## **LH1000**

### **BEARINGS, SERVICE & ASSEMBLY**

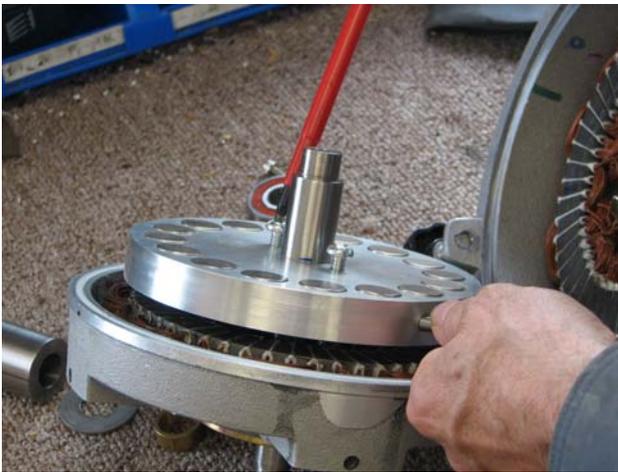
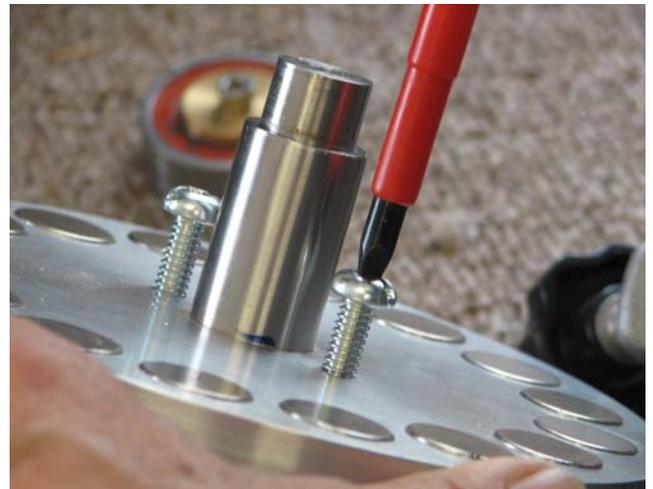
Technique for removing rotor showing jacking screws

To gain access to the lower bearing, the rotor must first be removed. This is done once the top is off by using the jacking screws that are supplied with the machine. These two screws are 1/4" diameter and 2 1/2" long. Tighten these evenly and fully and then the rotor can be removed. **BE CAREFUL!!!** The rotor is made with very strong magnets and will attract any iron or steel pieces that are near it. Once the rotor is removed, the lower bearing carrier can be removed by first removing the six screws on the outer edge of the carrier. This is a slip fit in the housing and should come right out. If there is corrosion it may be necessary to press this out.
